U.S. ARMY
H-25 HELICOPTER DROP TEST
22 October 1960

TREC
Technical Report 60-76

AvCIR 2-TR-125

March 1961

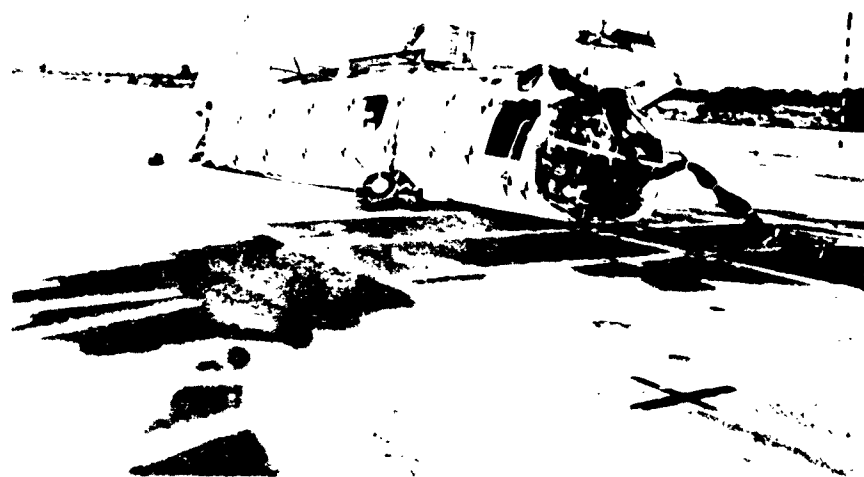
Figure 21. Post-Crash Front Quarter View

At ground contact, the light fuselage structure was pushed in by the stiffer landing gear, causing considerable distortion to the fuselage around the gear and internal buckling of the fuselage floor in the region of the forward landing gear attachments. The outer shell of the helicopter did not greatly distort except on the underside; however, there were a number of skin penetrations and breaks. (See Figures 20 through 25.) The occupant area, although distorted, was essentially intact.

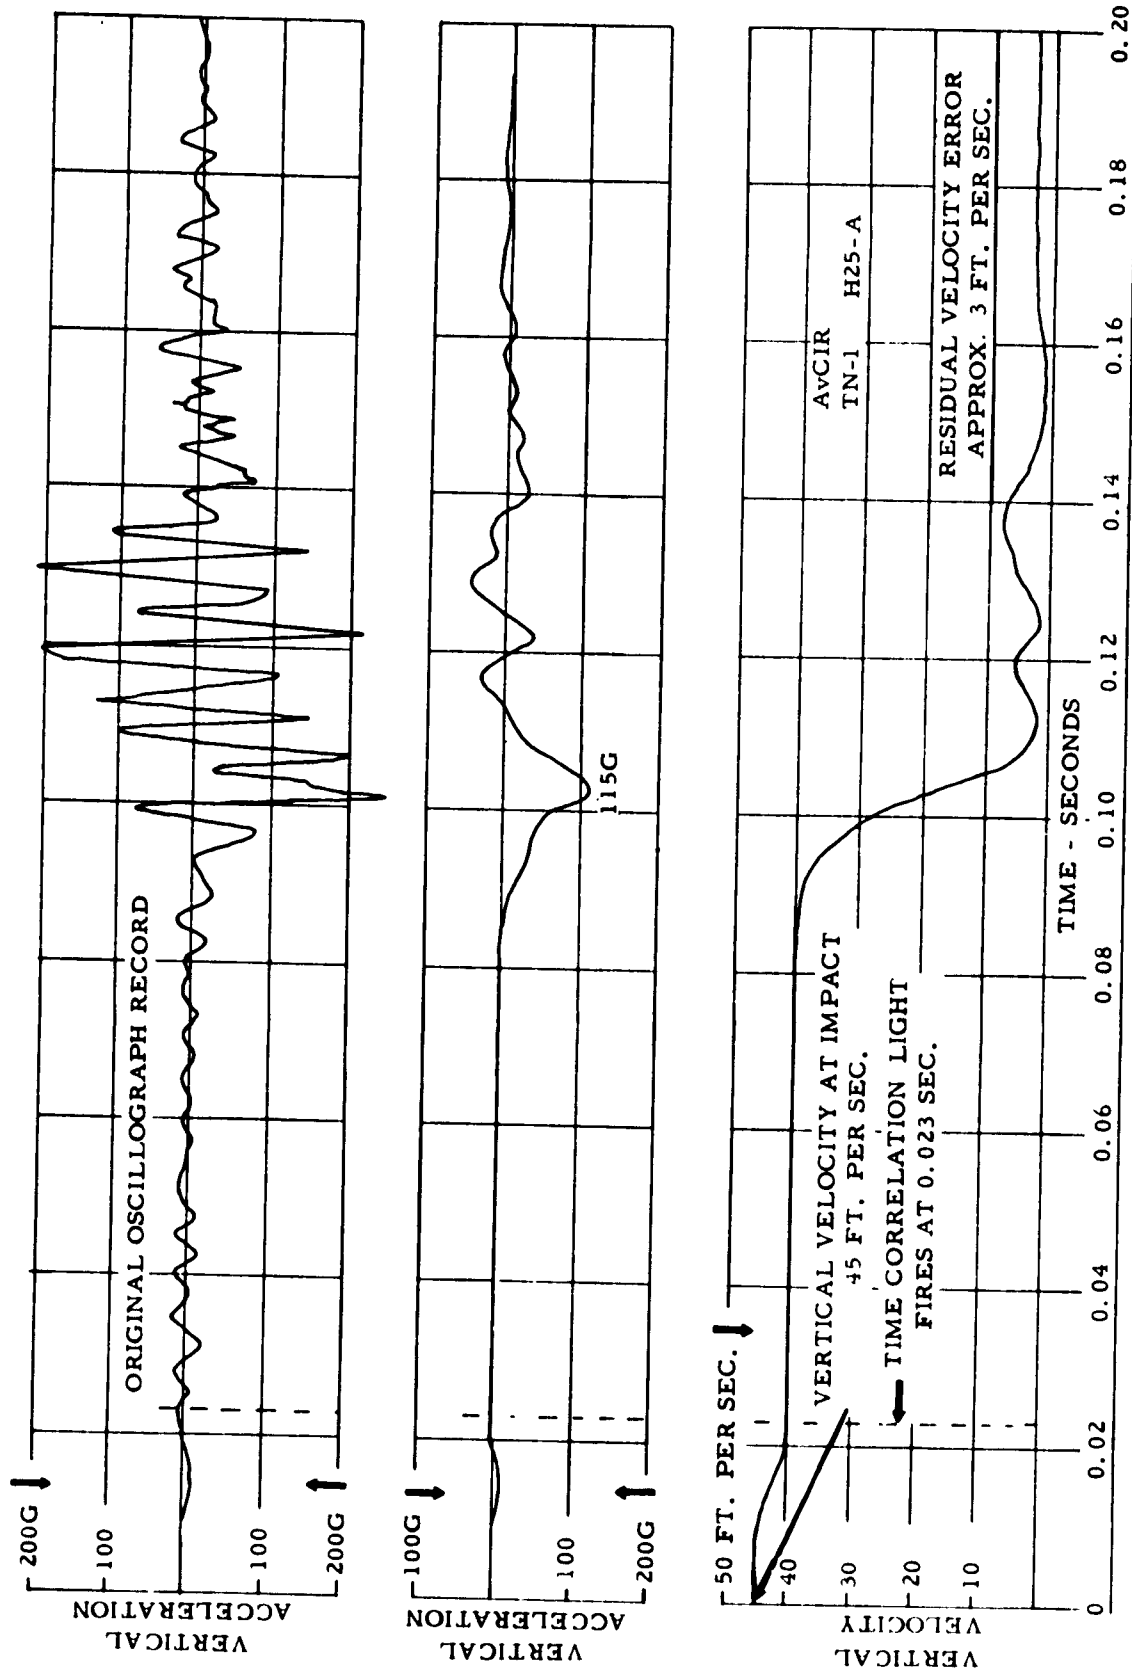
Figure 27. Acceleration and Velocity of Cockpit Floor

Referring to Figure 32 and to the sequence photographs of Figure 40-2 and Figure 40-3, it is clear that the landing gear did not appreciably decelerate the aircraft during the impact. The 4 f. p. s. reduction in vertical velocity of the cockpit-floor, as indicated in Figure 27 for the first 0.04 second of the impact, is not borne out by a similar value for the passenger cabin floor. This value of 4 f. p. s. is within the range of experimental error for tests of this nature, and can thus be disregarded. The primary acceleration pulse began at 0.085 second, at which time the forward portion of the fuselage began to contact the ground.

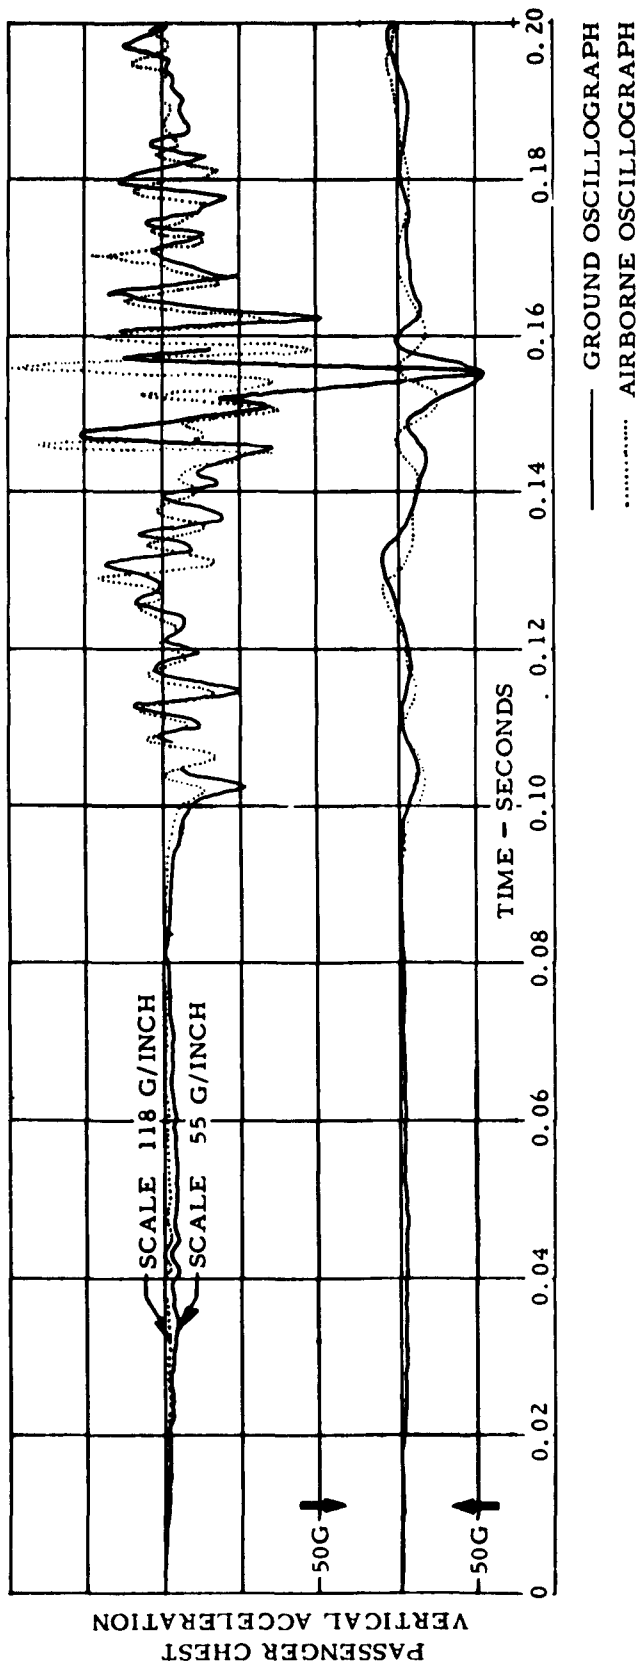
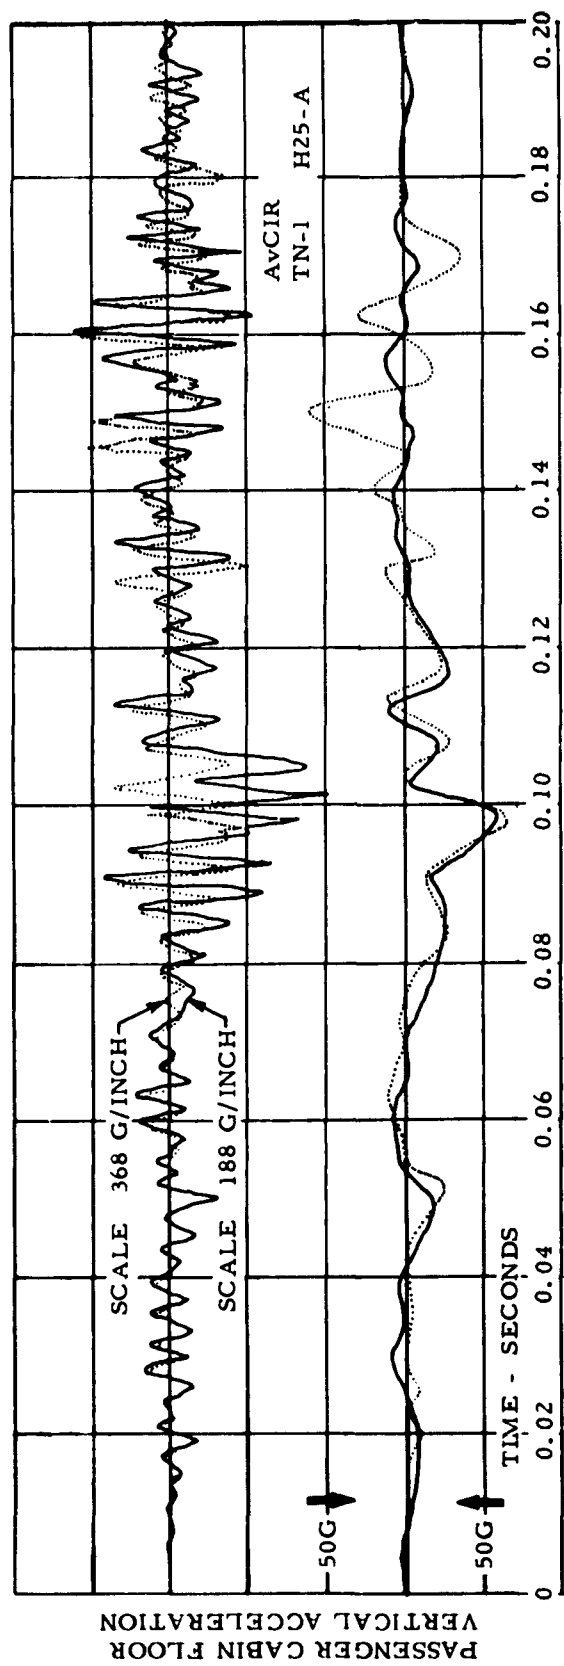
Figure 30. Comparison of Ground and Airborne Recording

Examination of the airborne instrumentation recording system following the crash found this equipment to be operable. The shock absorption devices had apparently functioned to properly protect the equipment and allow its operation during the test. A study of the ground and airborne oscillograph records later showed certain discrepancies in the airborne records. (See Figure 30.)

after impact to necessitate the temporary withholding of publication of eight channels of data recorded only on the airborne recorder. These channels are indicated in Table I and Figure 10. In Figure 30, both the original and smoothed acceleration-time curves (for ground and airborne recording) are shown for the passenger cabin floor and passenger chest accelerations. The first serious discrepancy in both cases is seen to occur at about 0.13 second. A plot of the lateral, longitudinal, and vertical accelerations of the airborne instrument package, given in Figure 31, shows that, at 0.128 second, a severe disturbance in the longitudinal acceleration record occurred. This disturbance was not a true acceleration, however, and was probably due to a poor connection at the emergency-disconnect in the umbilical cord at the crane. This disturbance at 0.128 second was clearly evident in eleven of the airborne recorder channels, although to a much lesser degree in all cases except for the fuel tank pressure record. Only minute evidence of this disturbance was observed in the other ground-recorded data.

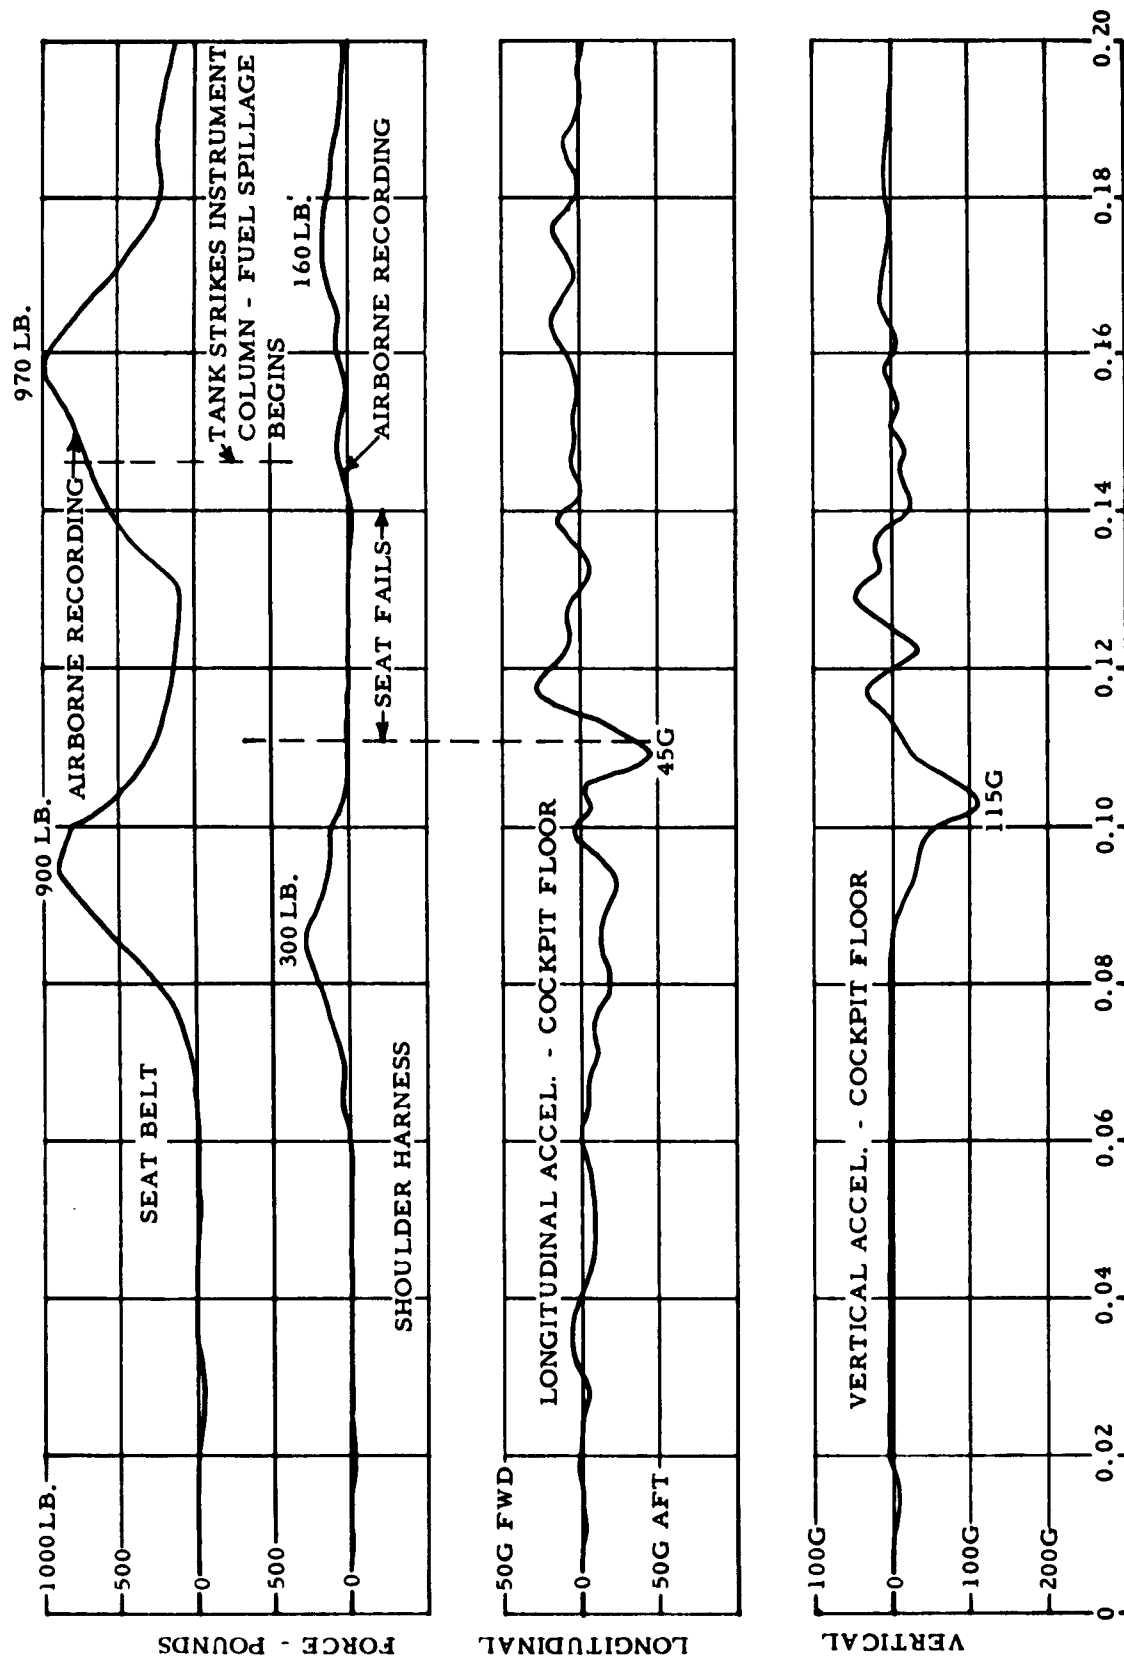
Figure 38. Range Extender Tank Loads

Acceleration of the airborne package exceeded the design value of 14.5G at 0.19 second as may be observed in Figure 31. The results obtained from the airborne recorder are thus considered doubtful, pending further analysis of the data. The two channels of airborne data presented in Figure 38 (range extender tank seat belt and shoulder harness) are accurate to 0.13 second and are significant beyond this time in that the indicated loads in these belts are low.

The seat belt and shoulder harness loads were, as for the pilot, relatively low. (See Figure 38.) They remained below 970 pounds and 300 pounds, respectively, building to or near these values as the longitudinal acceleration of the cockpit floor began to build up. Observation of the upper portion of the seat through high-speed camera No. 1A indicated that the collapse of the seat began at 0.11 second, i. e., at or near the time for the peak accelerations of the cockpit floor. This time was the same as that for the failure of the pilot seat. Buckling of the forward legs of the seat allowed the seat to rotate and move forward. At 0.145 second the forward inboard corner of the tank contacted the instrument console (Figures 25 and 43) rupturing the fibre-glass tank, and fuel spillage began. Other tank failures were: (1) failure in the pan area of the seat (a cushion was placed between tank and seat), and (2) separation of the upper and inboard seams due to contact of the filler cap with the top window-sill of the right hand window of the aircraft.

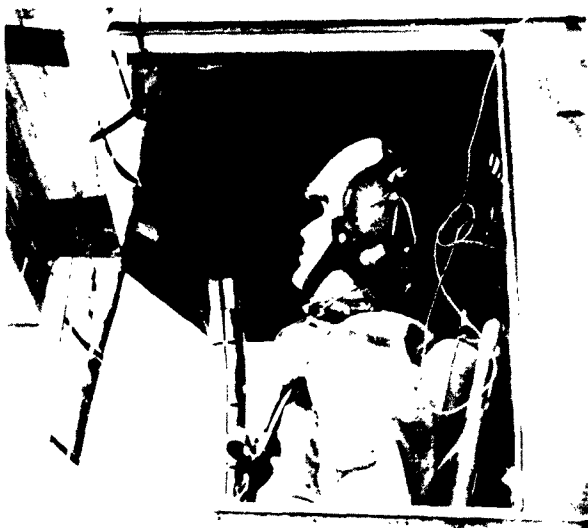
Figure 40-8. Sequence Photograph, H-25 Drop Test

PILOT'S HEAD AGAINST STRUCTURE
